Amphibious Bulldozer

Restoring an Amphibious Bulldozer as Part of Earthquake Reconstruction Support

Restoration of Amphibious Bulldozer

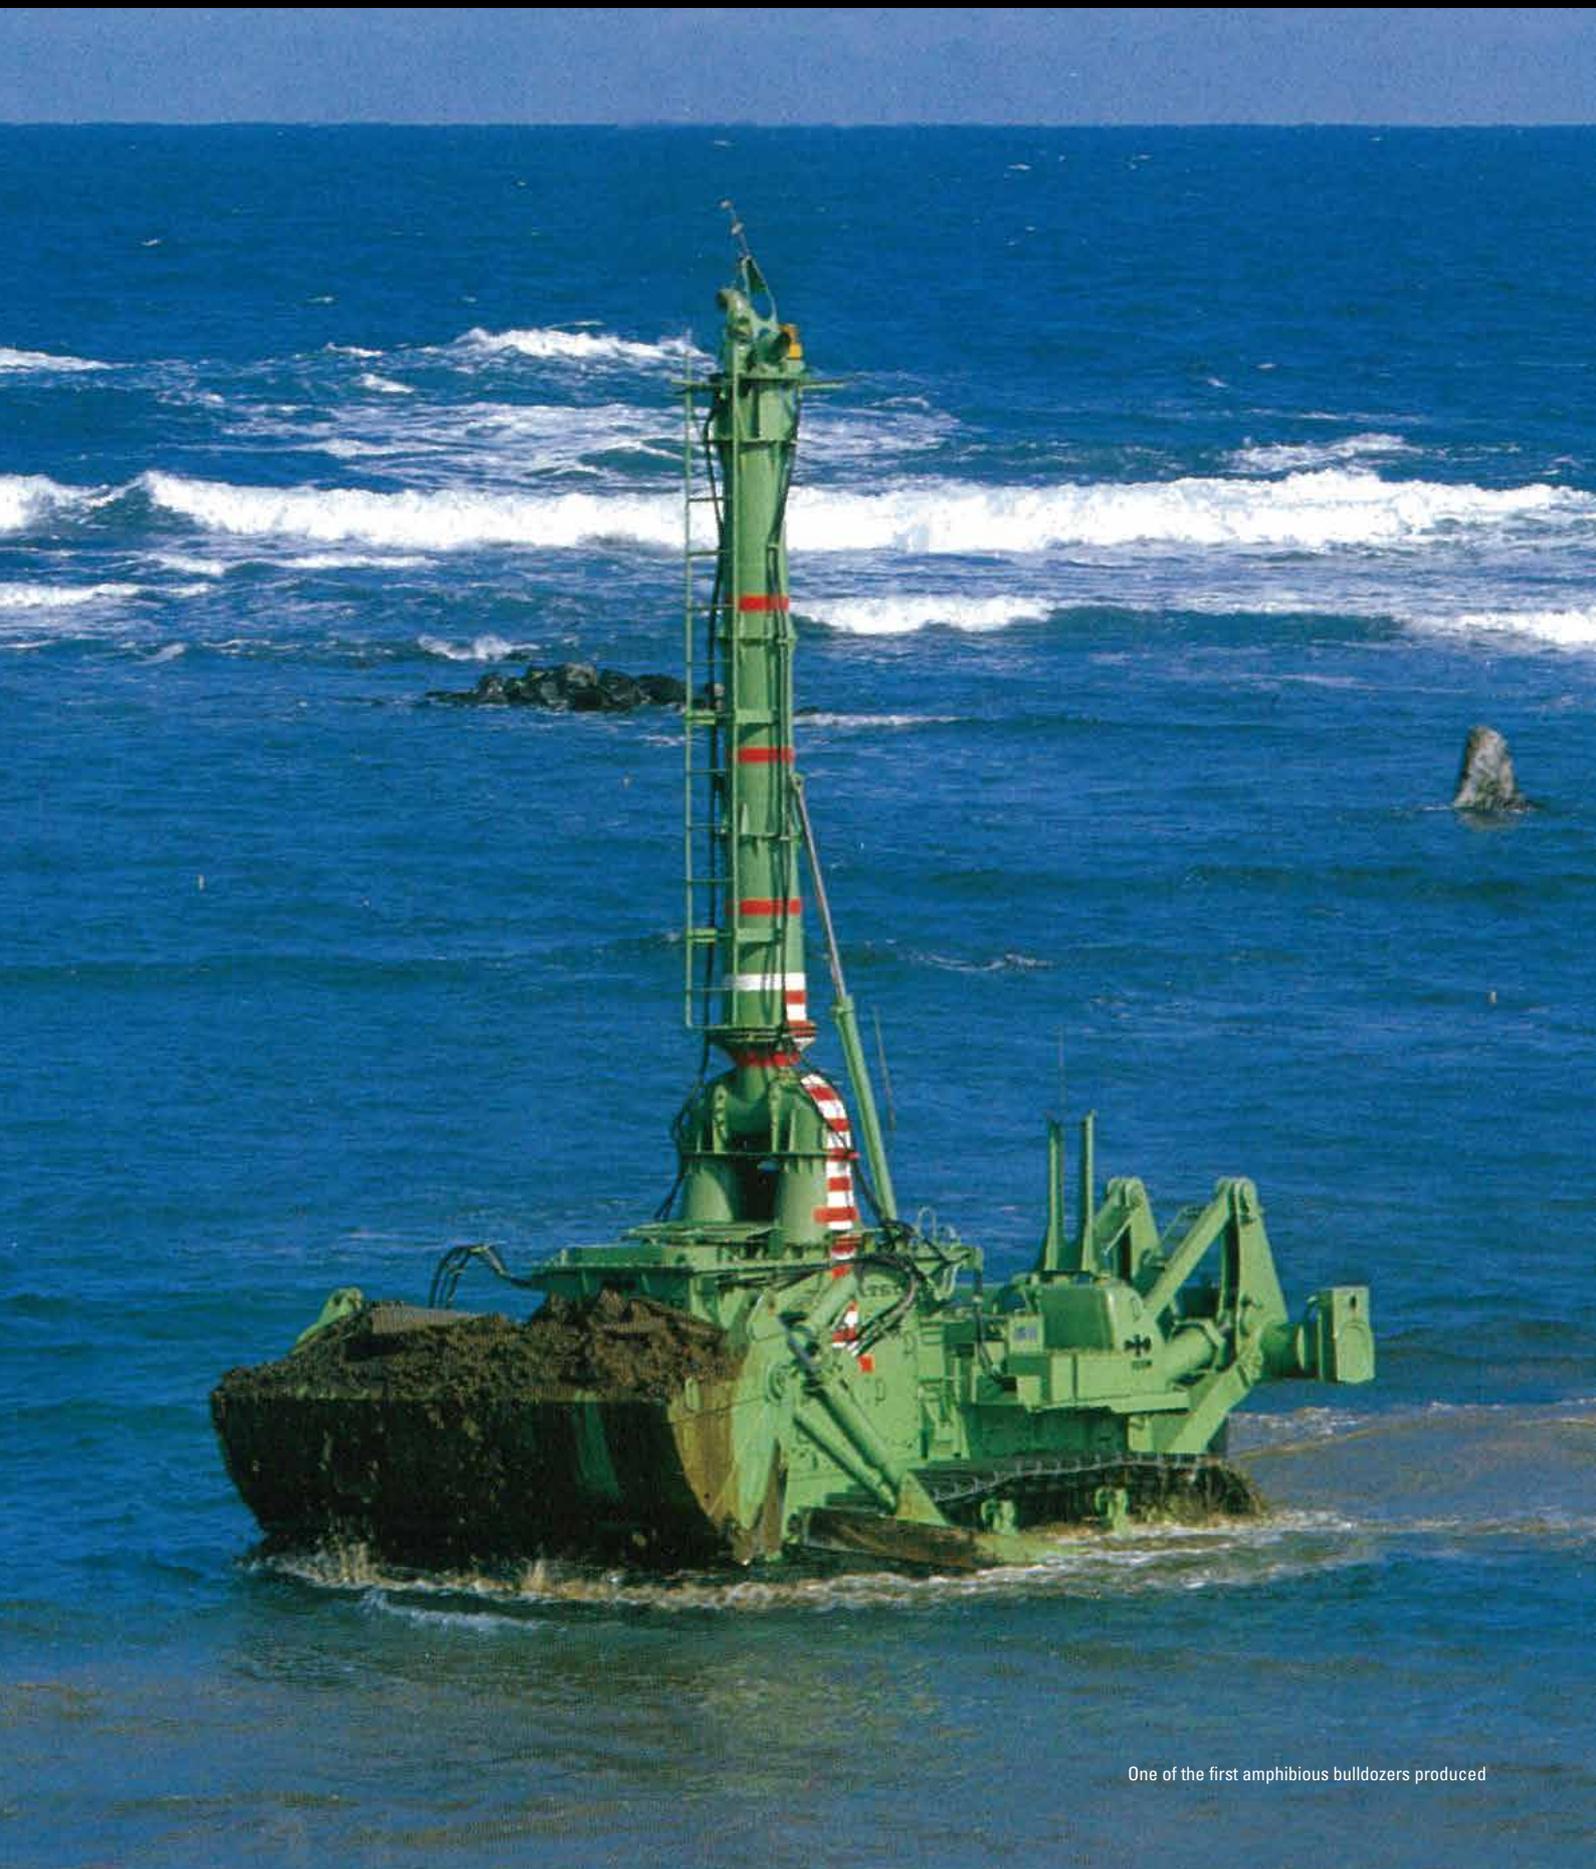
One of the first amphibious bulldozers produced

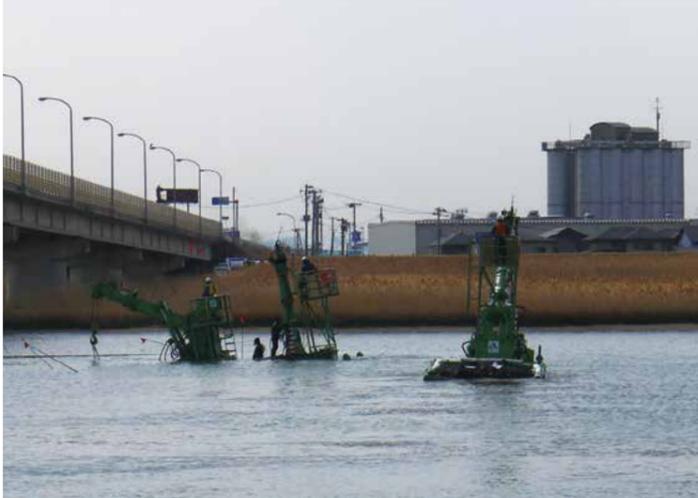
Two amphibious bulldozers working in tandem in the Natori River for the post-disaster reconstruction project

One of the job sites for the bulldozer was the Yuriage Bridge near the mouth of the Natori River in Natori City, Miyagi Prefecture. When the earthquake hit, the tsunami washed away sediment that served as the foundation for bridge supports. These supports had been left exposed ever since, and an amphibious bulldozer was needed for performing backfilling and bed protection work.

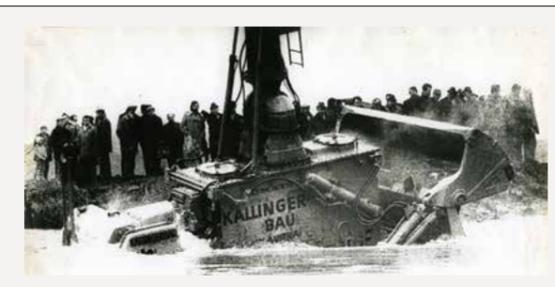
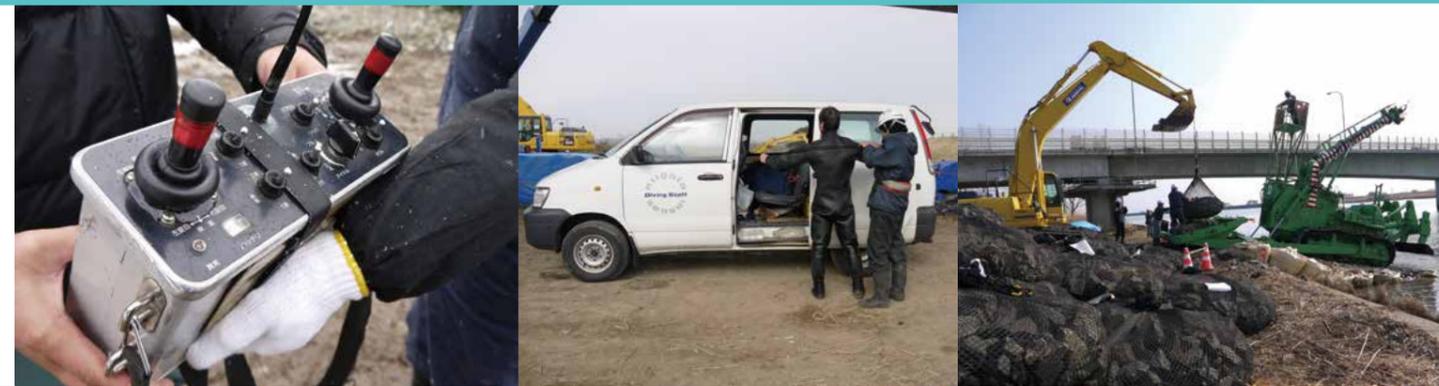
Remote controller for the amphibious bulldozer

Divers for guiding underwater work

Loading rocks onto an amphibious bulldozer with a hydraulic excavator

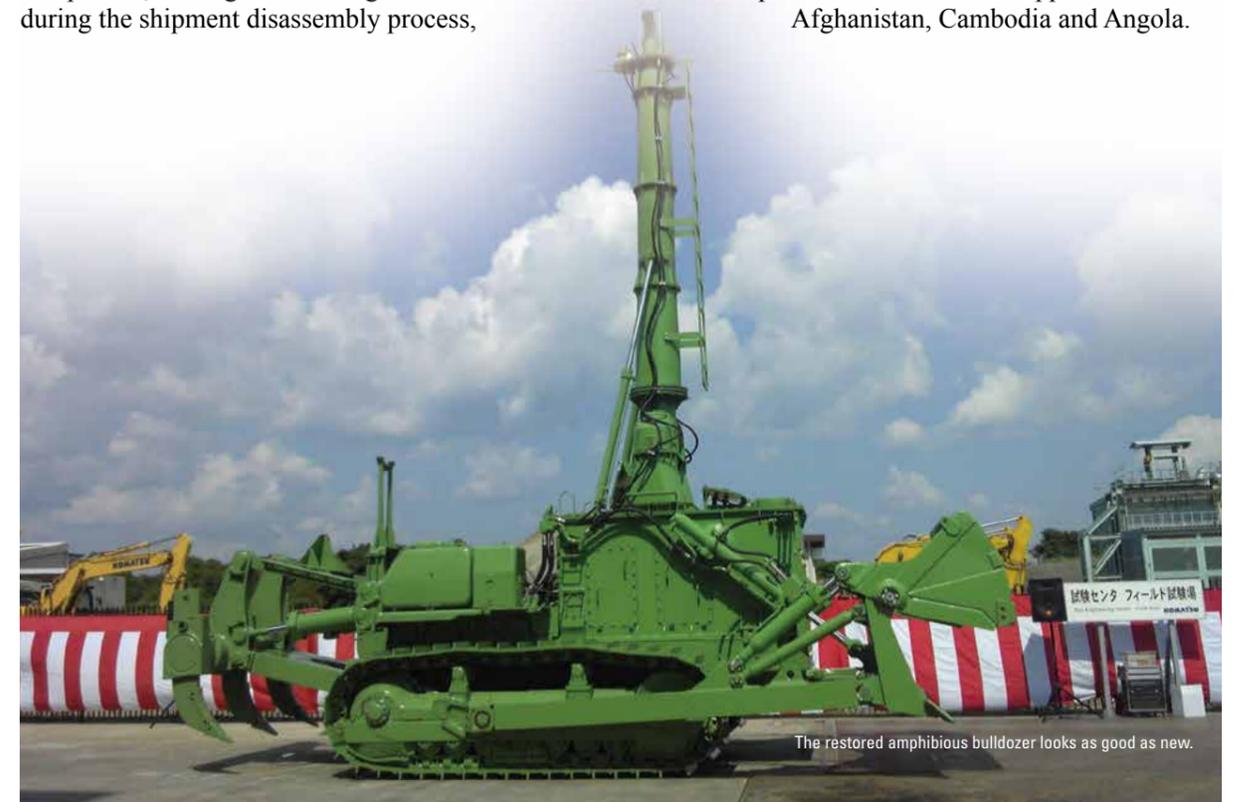
The restored amphibious bulldozer looks as good as new.

In September 2012, the amphibious bulldozer was finally restored thanks to the technical skills of many people and the cooperation of numerous companies.

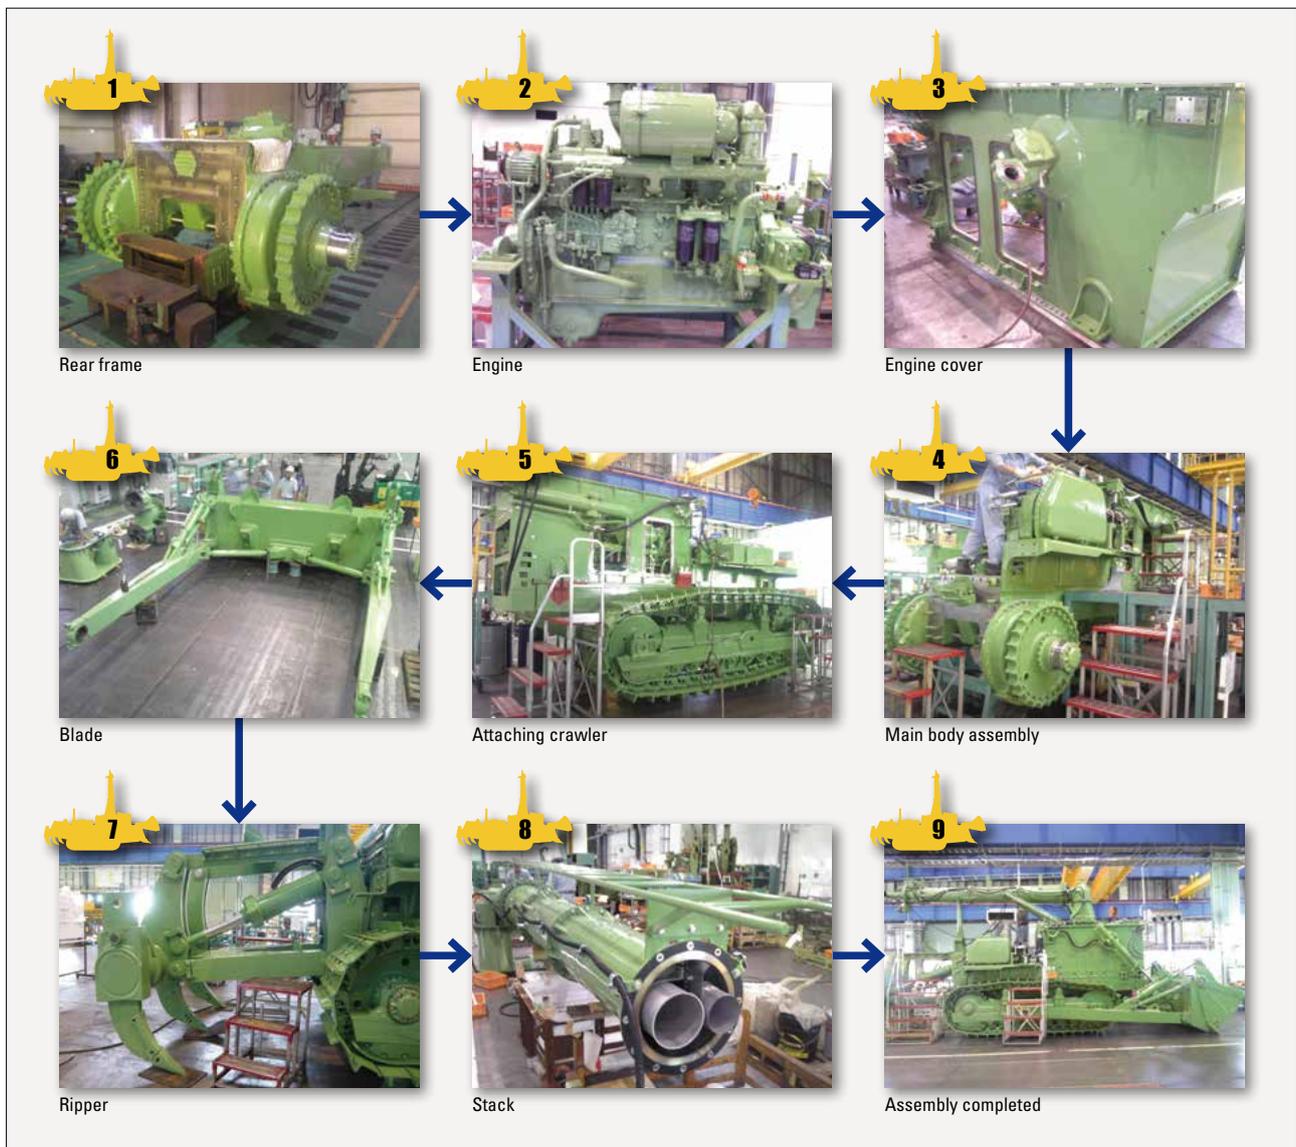
<Reassembly after Restoration>

<The Original Condition>

The amphibious bulldozer sent back to the Osaka Plant sustained extensive damage from rust and corrosion.

- Number of redesigns: Approx. 250
- Number of parts ordered: 3,458
- Number of reconstructed and revised drawings for sheet metal cutting: 247
- Since many of the parts no longer existed, it was challenging to procure all the parts.
- Damage to the suspension and the main frame was so severe that Komatsu had to reconstruct the sheet metal and the casting parts. The molds for the parts were long gone and needed to be made from scratch.
- Each part was applied with three layers of protective coating.
